## PART THE SECOND: THE

## ARCHITECTURE OF THE CHURCH

About three years ago the Parochial Church Council decided to produce for the use of visitors a new Guide to St Mary's and the Churchwardens asked the Trust to become involved. While it was clear that the existing Guide needed revision and updating (that has now been published separately), I formed the view, and the PCC agreed, that the architecture of the Church and its history warranted a more detailed and fully illustrated work.

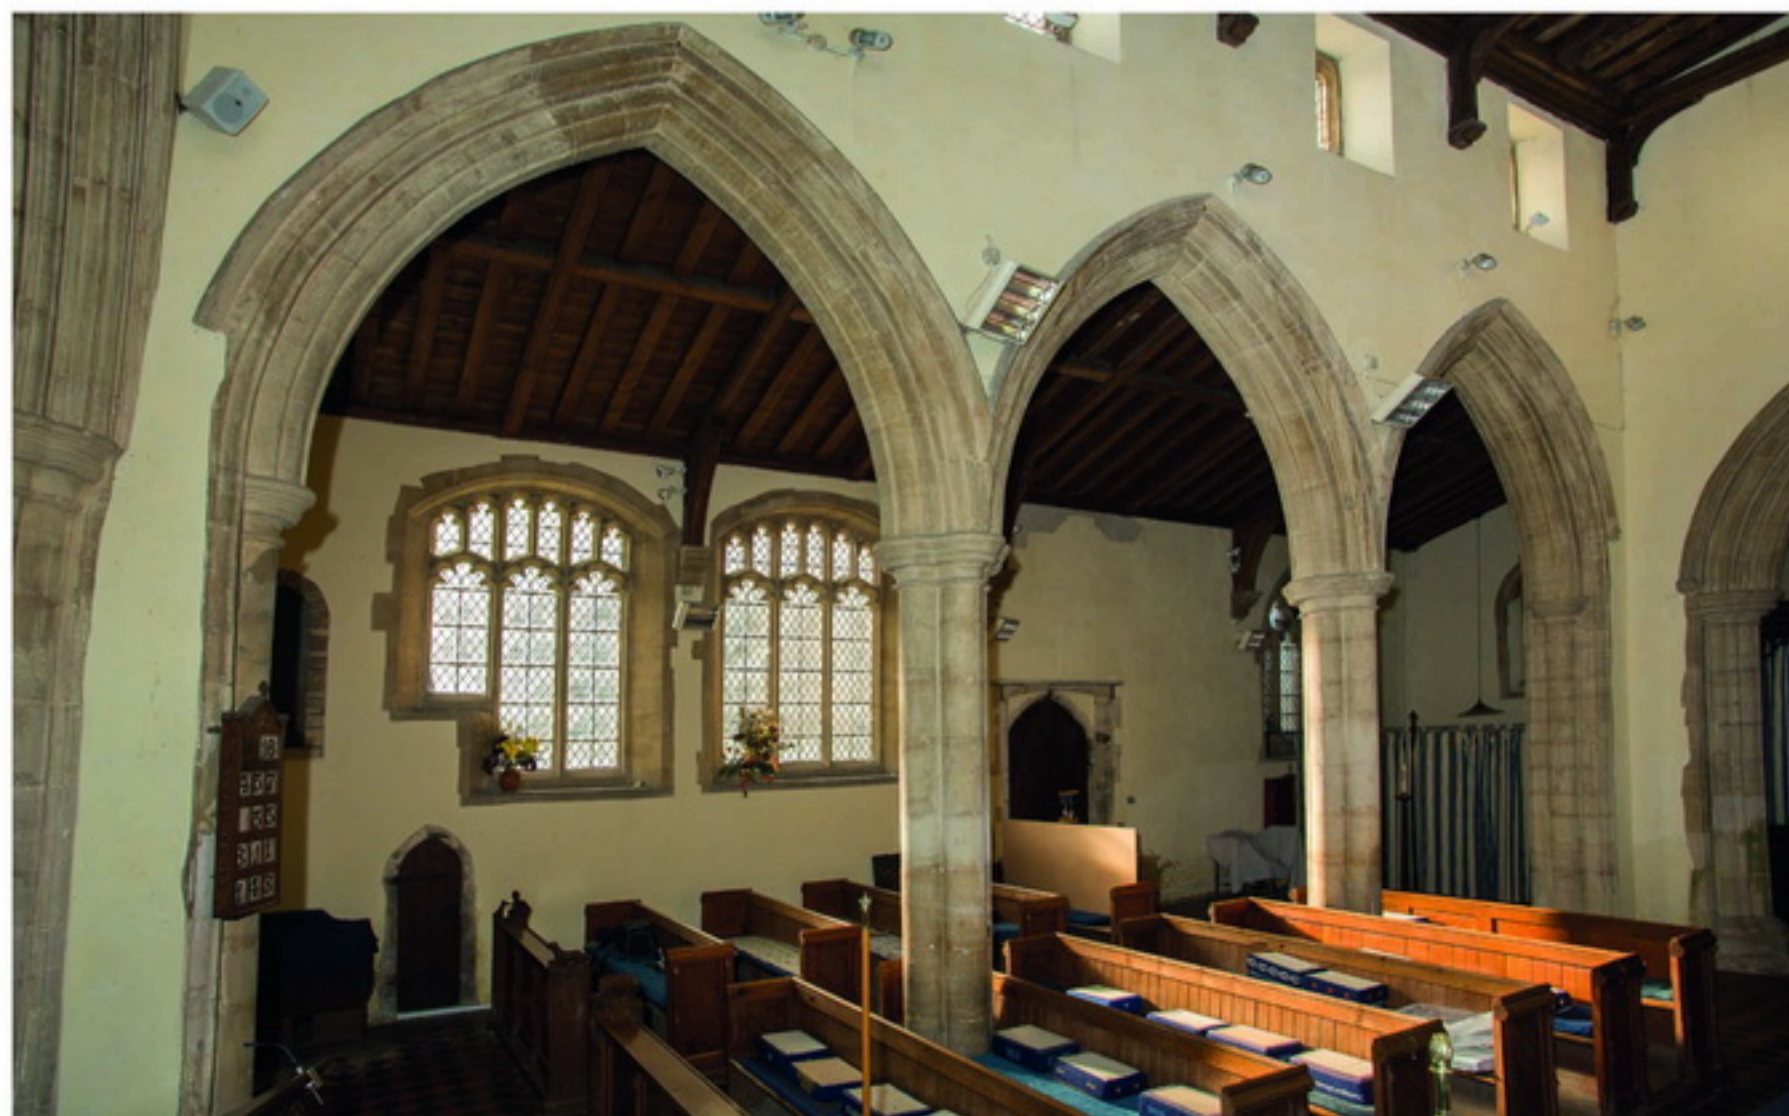
*Plate 66* The South Arcade and Aisle

Pevsner describes the South Arcade thus: *the S arcade is of c 1300, with high quatrefoil piers with deep continuous hollows in the diagonals and sunk quadrant arch mouldings*<sup>179</sup>.

the latter was widened later. Each of the nave arcades has three bays. The VCH considers that work on the North Arcade (*Plate 74*) was commenced before the South as the detail there is better than the South Arcade (*Plate 66*). However, Pevsner says the South Arcade is c1300 and the North Aisle later. The fabric of the North Aisle is certainly richer than the South.

In the wall of the South Aisle are two restored trefoil windows in the segmented perpendicular style matching those in the North Aisle. The lean-to roof is modern. The restored west window replicates that of

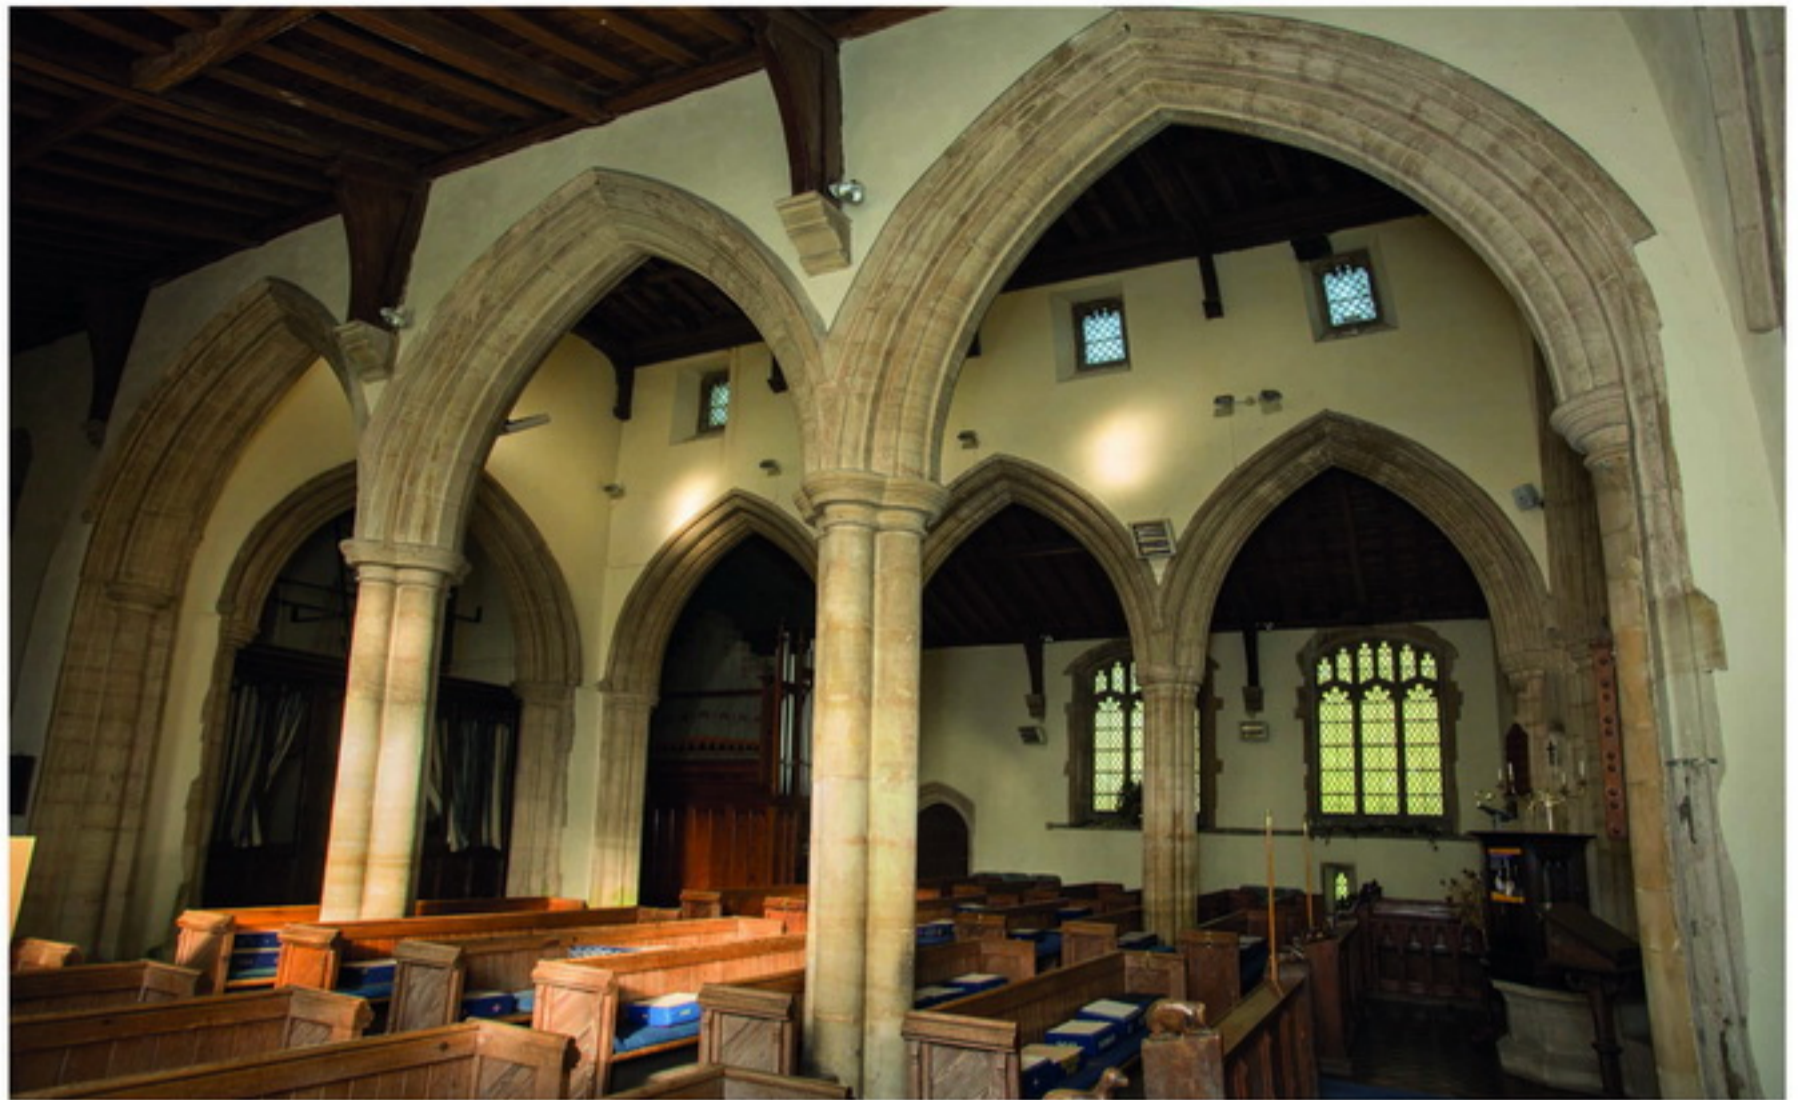
Plate 67 North Aisle viewed through the South Arcade

At the east end of the aisle two windows each with three lights and tracery under a segmental head date from the 1872 restoration in the perpendicular style (see above at Plates 21 and 67). Under the window to the right is a small
